SOLID WASTE RECEIVER

Fifth Status Report
of the
Receivership for the Government of Guam
Guam Solid Waste Authority
Pursuant to the Order of the
United States District Court of Guam

Presented by
Gershman, Brickner & Bratton, Inc.
May 10, 2023

6. Ordot Dump Post-Closure Facility Condition / Operations Update May 10, 2023

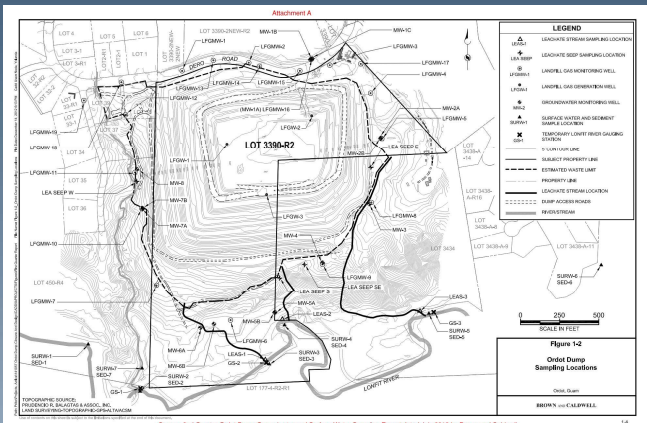
Figure 1-2
Dump Site
Sampling Locations

Source: 2nd Quarter Onsite Dump Groundwater and Surface Water Sampling Report dated July 2013 by Brown and Caldwell

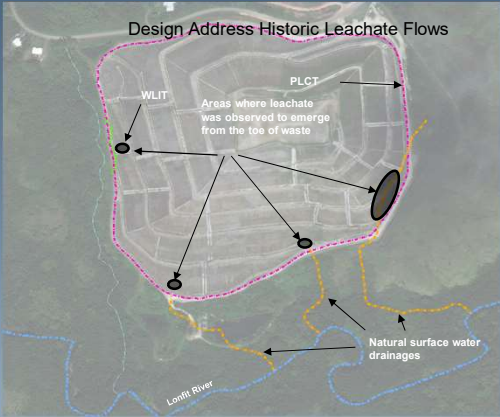
Design Address Historic Leachate Flows

WLIT

PLCT

Areas where leachate was observed to emerge from the toe of waste

Natural surface water drainages

Lorril River

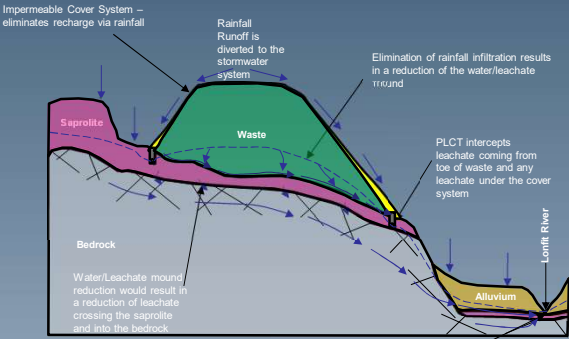
Impermeable Cover System – eliminates recharge via rainfall

Rainfall Runoff is diverted to the stormwater system

Elimination of rainfall infiltration results in a reduction of the water/leachate mound

PLCT intercepts leachate coming from toe of waste and any leachate under the cover system

Bedrock

Water/Leachate mound reduction would result in a reduction of leachate crossing the saprolite and into the bedrock

Alluvium

Groundwater ultimately discharges to the Lorifit River
