**ORDOT DUMP  
ORDOT-CHALAN PAGO, GUAM**

**Environmental Data Summary Report**

July 2005

*Prepared by*  
Dueñas & Associates Project Team (Dueñas & Associates, Inc. URS  
Corporation, and Mink & Yuen, Inc.)

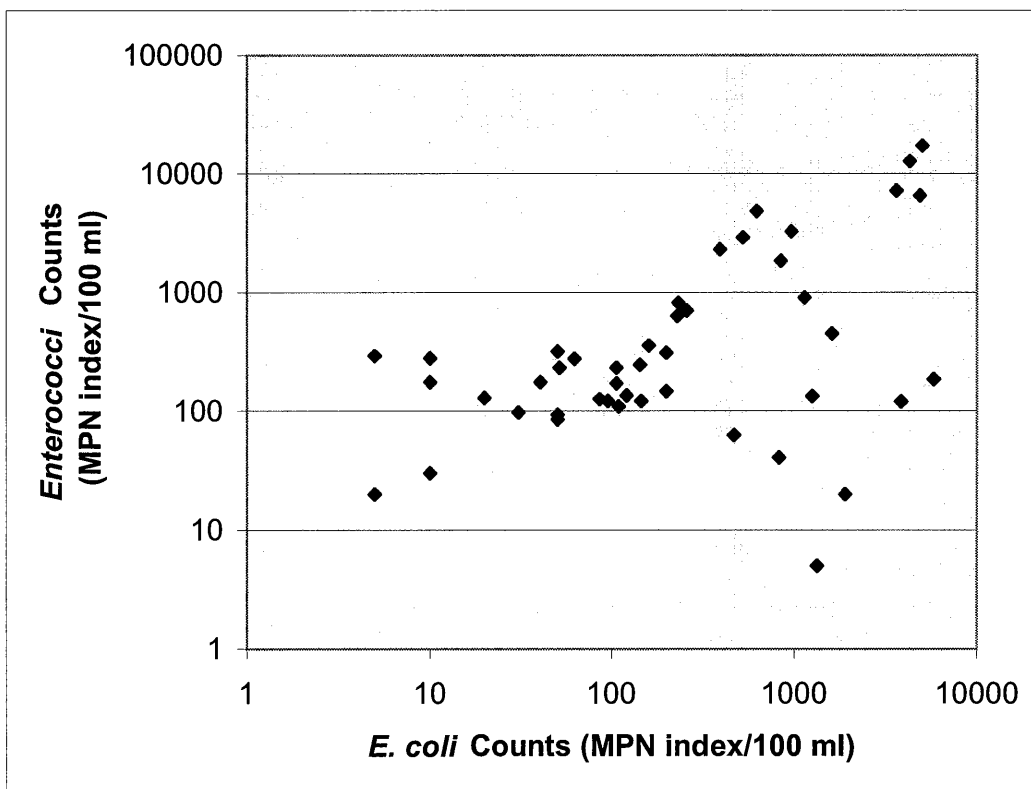
**Figure 1: Relationship between *E. coli* and *Enterococci* counts in surface waters of the Lonfit-Pago River System (Oct. '02 – May '03)**

In general, fecal indicator bacterial counts were poorly correlated with one another both in space and time (Figure 1.). This suggests that they have very different survival times and reproductive capabilities in the environment.

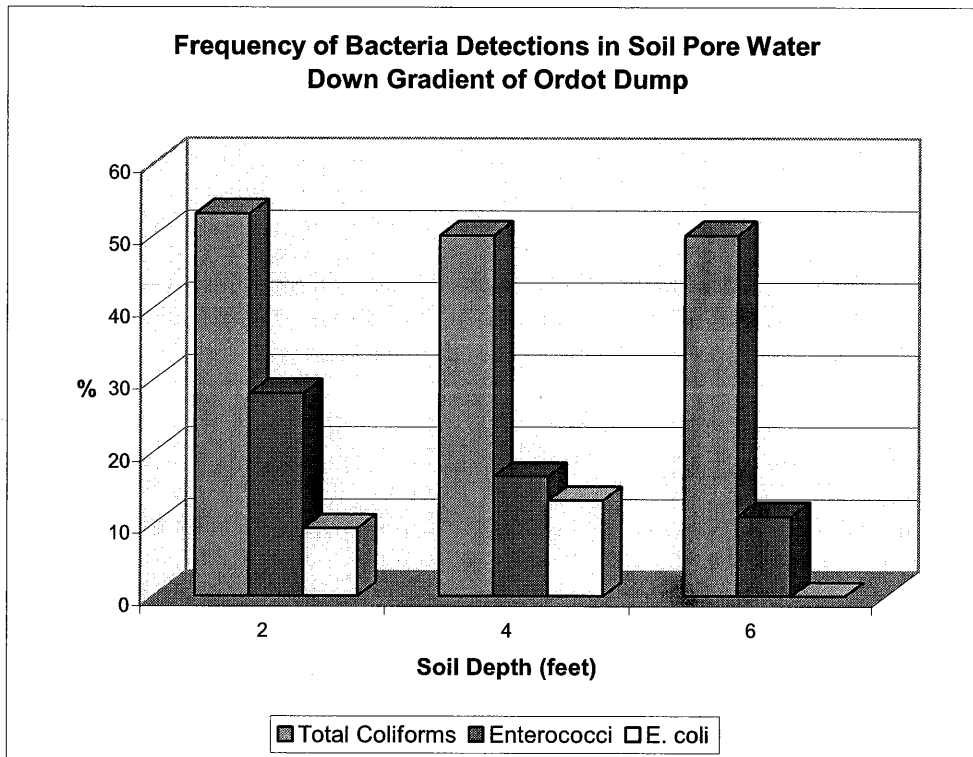
**Figure 2: Frequency of bacteria detections in soil pore water down gradient from Ordot Dump (Oct. '02-May '03)**

It is interesting to note that the frequency with which *E. coli* and *Enterococci* were detected in soil pore water samples was depth related with the fewer detections at six feet than at two feet (Figure 2). In contrast, total coliforms were encountered in approximately 50% of the samples collected at all three depths. It is also noteworthy that *Enterococci* were detected more often than *E. coli* at all soil depths.
